# **INDOOR AIR QUALITY ASSESSMENT**

**Watertown Administration Building  
149 Main Street  
Watertown, Massachusetts**

Prepared by:  
Massachusetts Department of Public Health  
Center for Environmental Health  
Emergency Response/Indoor Air Quality Program  
December 2006

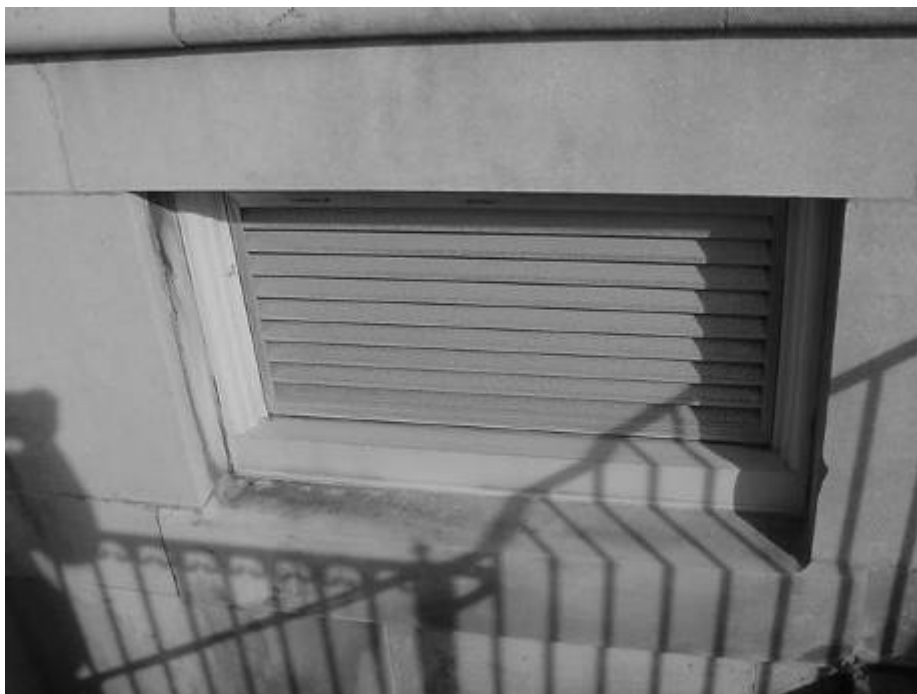
**Picture 1**

Another potential source of mold growth and/or odors was observed on the exterior of the building in the form of accumulated leaves/plant debris in close proximity to fresh air intakes (Picture 1). A subterranean pit located along the front of the building is designed to allow air flow into the basement AHU. Over time leaves, trash, plant debris and other materials can accumulate in these pits. If materials in this pit become wet repeatedly, they can grow mold and provide a source of mold spores and odors, which can be drawn into the HVAC system via the intake vents.

**Fresh Air Intake for HVAC System**

6. Clean leaves and other debris from the exterior of fresh air intakes as needed to prevent the entrainment of mold spores/odors into the ventilation system.

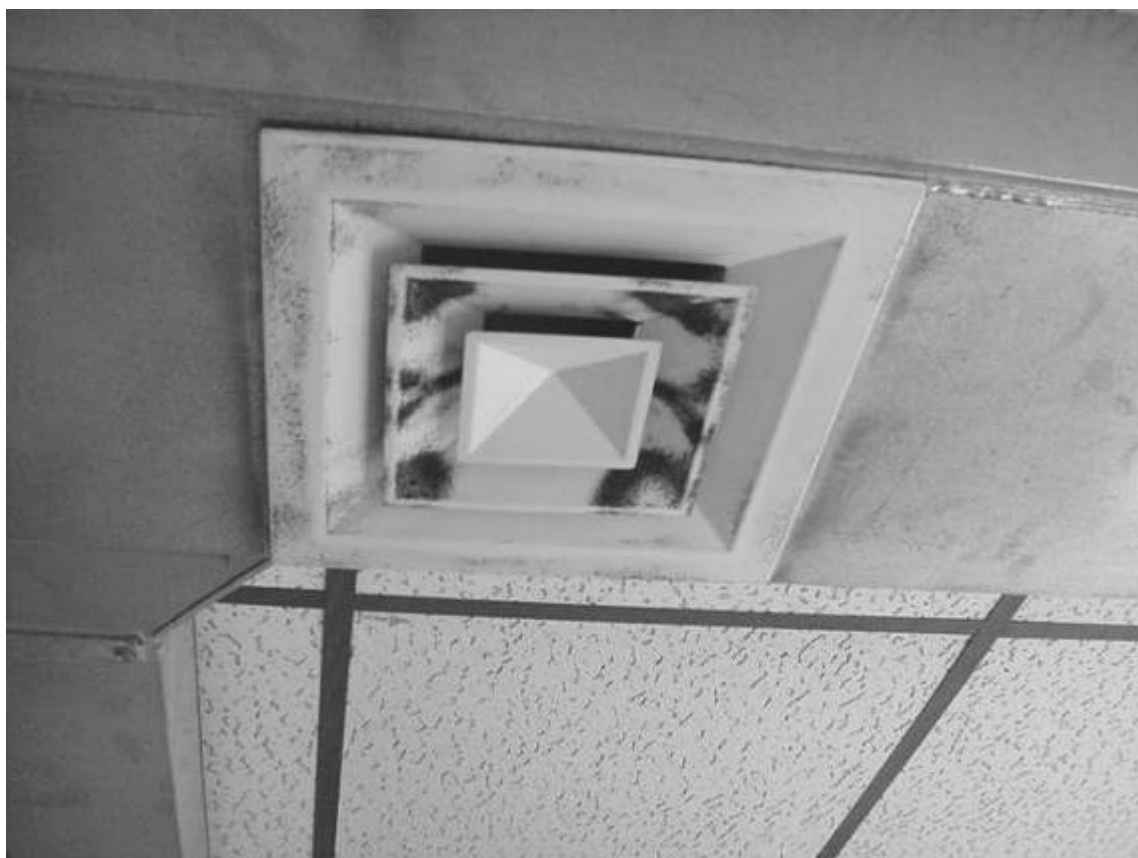
**Picture 2**

During the assessment, visible mold growth was observed on the surface of metal ductwork and vents (Pictures 2 and 3). Metal is a non-porous surface constructed of materials that are not likely to be colonized by mold. However, these non-porous surfaces were coated with materials (e.g., dust) that can support microbial growth if exposed to moisture for extended periods of time. Regular cleaning of non-porous surfaces can remedy this type of mold contamination. In contrast, porous materials (e.g., boxes, books, insulation and ceiling tiles) should be removed/replaced to prevent further mold contamination problems.

**Supply Air Diffuser, Note Black Debris/Likely Mold Growth on Surface of Vent**

1. Remediate mold growth observed on vents/ductwork in a manner consistent with recommendations in “Mold Remediation in Schools and Commercial Buildings” published by the US Environmental Protection Agency (US EPA, 2001). Copies of this document can be downloaded from the US EPA website at:  
[http://www.epa.gov/iaq/molds/mold\\_remediation.html](http://www.epa.gov/iaq/molds/mold_remediation.html).

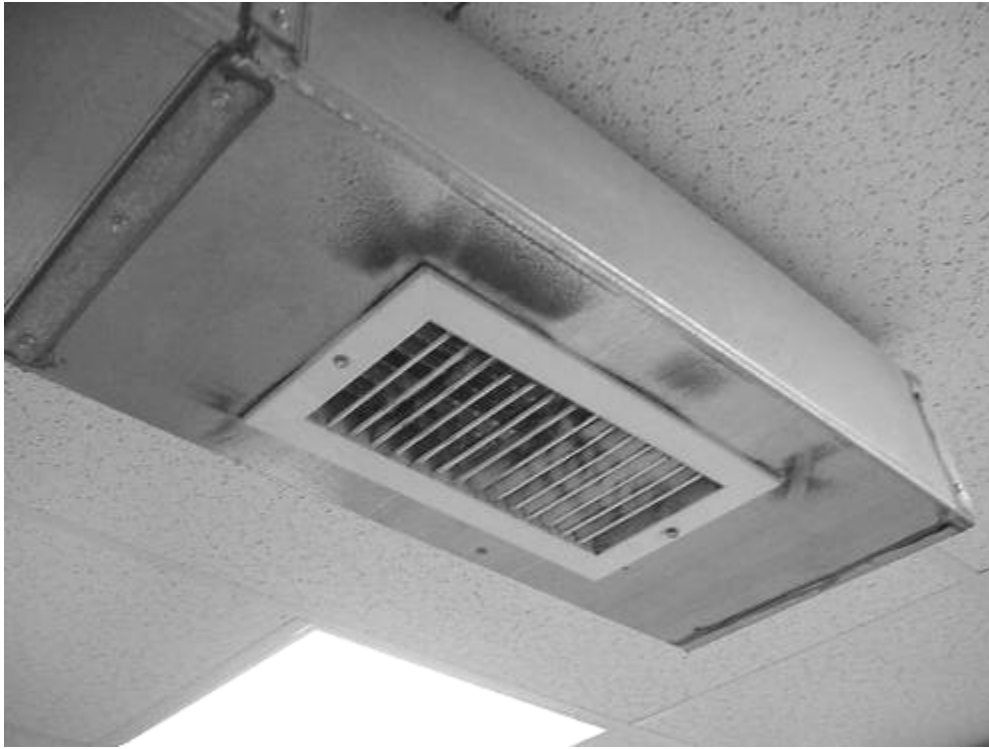
**Picture 3**

**Supply Air Diffuser, Note Black Debris/Likely Mold Growth on Surface of Vent**

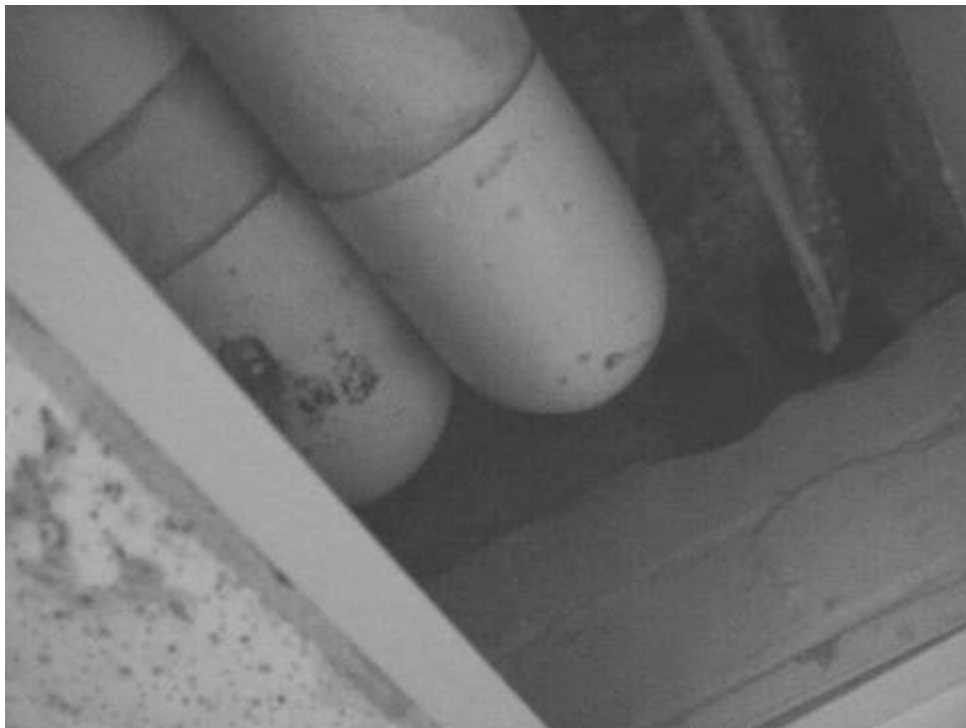
**Picture 4**

Visible mold growth was also observed on pipe insulation above water-damaged ceiling tiles in the lower hearing room (Picture 4) and on pipe insulation in the basement air-handling room (behind the mail room/Picture 5). The pipe insulation appeared to be a fiberglass material, however due to the age of the building and the potential for asbestos containing materials to be present, it is recommended that the insulation be properly be identified by a licensed asbestos inspector prior to removal.

**Visible Mold Growth on Pipe Insulation above Water Damaged Ceiling Tiles in Lower Hearing Room (Near Entrance)**

2. Due to the possible presence of asbestos in the building, the pipe insulation should be evaluated by a licensed asbestos inspector prior to removal/remediation. If deemed not to be a product with asbestos, then follow guidance in recommendation 1.

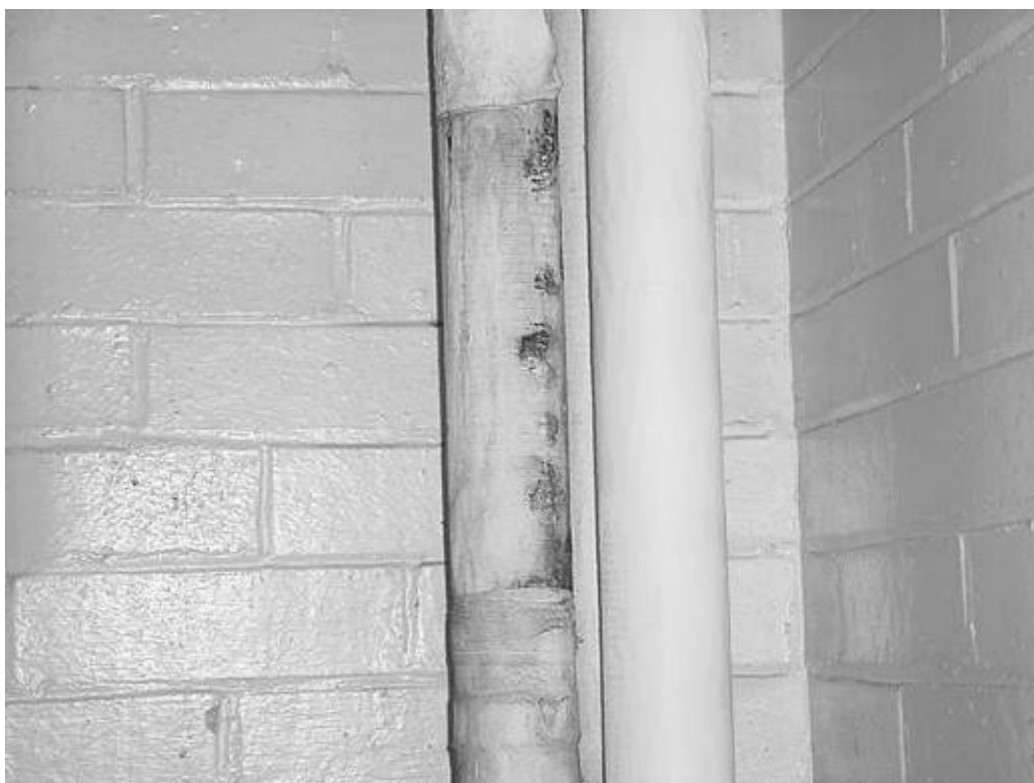
**Picture 5**

**Visible Mold Growth on Pipe Insulation in the Basement Air Handling Room (Behind the Mail Room)**

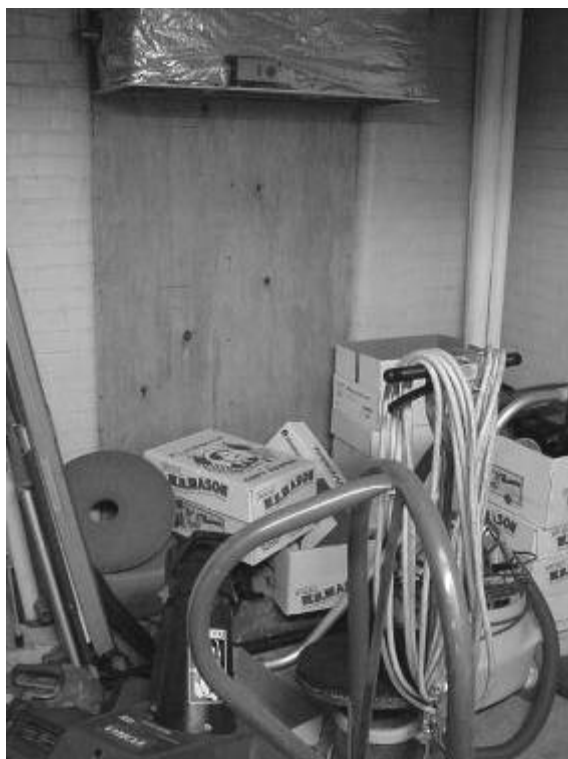
**Picture 6**

CEH staff observed a number of cardboard boxes and other porous items stored on the floor of the basement air-handling room (Picture 6). These items should be elevated (e.g., placed on pallets, tables) to prevent moisture/water damage and potential mold growth. Such materials would be particularly prone to support mold growth during periods of elevated relative humidity.

**Cardboard Boxes Stored on Floor of Basement Air Handling Room**

7. Refrain from storing porous materials (e.g., cardboard boxes) directly on floor of air-handling room. Inspect and discard any water damaged cardboard boxes. Disinfect any

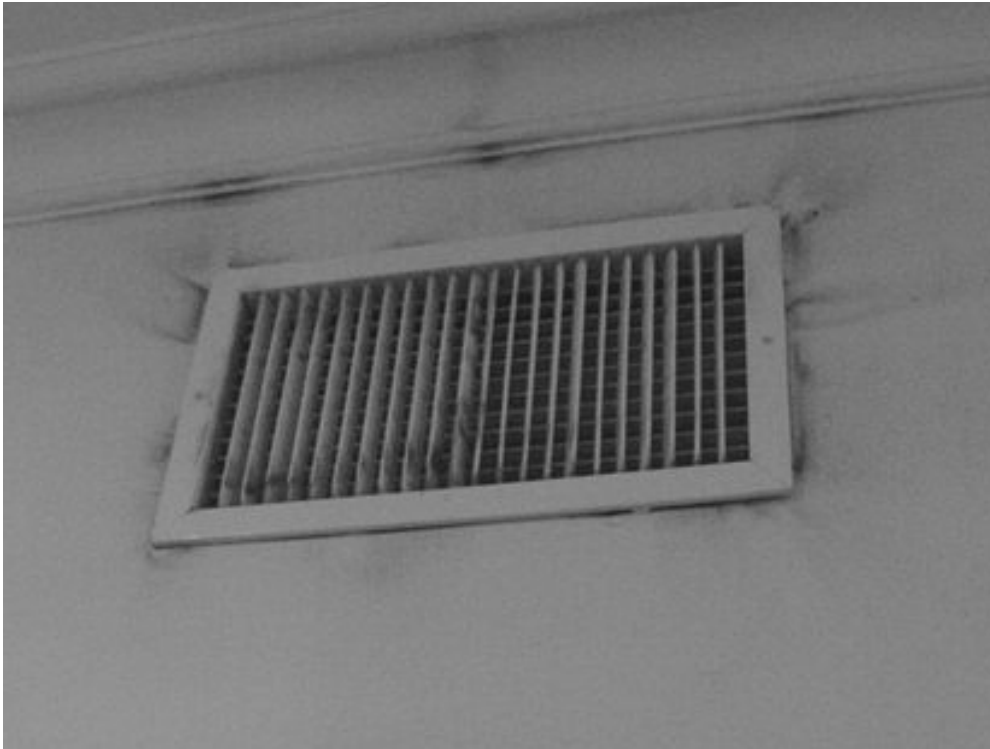
**Picture 7**

Dirt/dust accumulation was observed around vents that had become dislodged from the wall in the main hallway (Pictures 7 and 8). The space between the vents and wall allows air to escape from the ductwork and draw air, dust and other particulates from the wall cavity resulting in staining around vents. In contrast, this phenomenon was not observed around vents that were flush with the wall.

**Dust/Debris around Vents in Main Lobby Where Air is Escaping around Space between Vent and Wall**

3. Clean supply and exhaust vents regularly of accumulated dust.
4. Seal around or make repairs to vents in main hallway (Pictures 7 and 8) to prevent escape/draw of air from wall cavities.

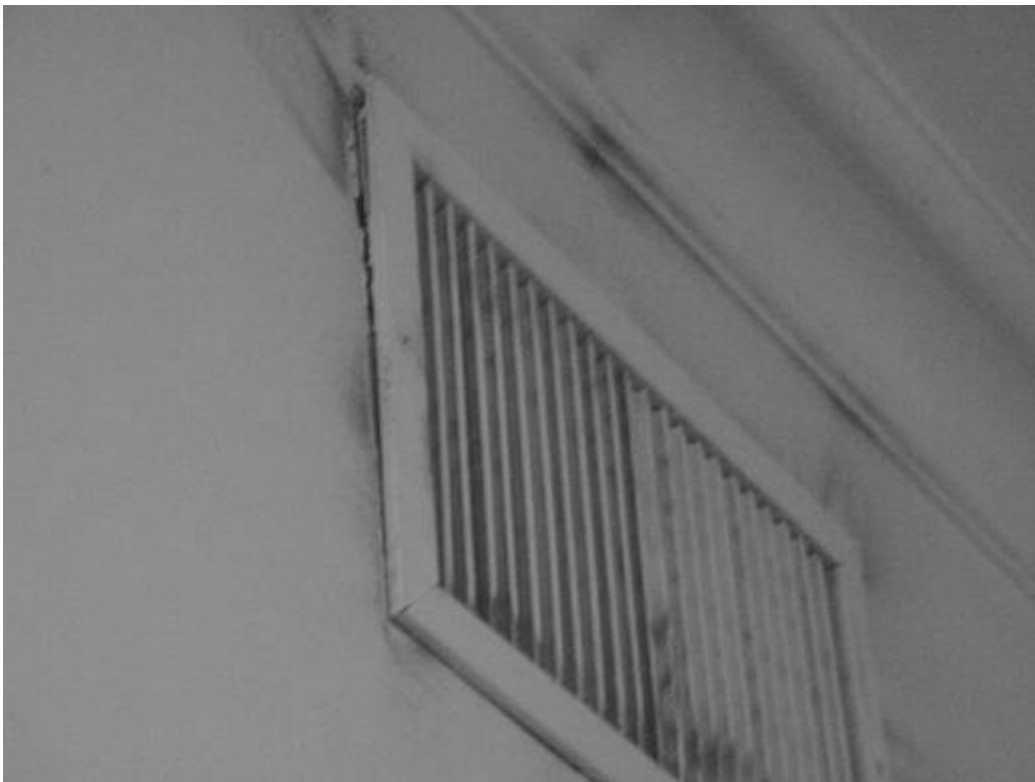
**Picture 8**

**Dust/Debris around Vents in Main Lobby Where Air is Escaping around Space between Vent and Wall**

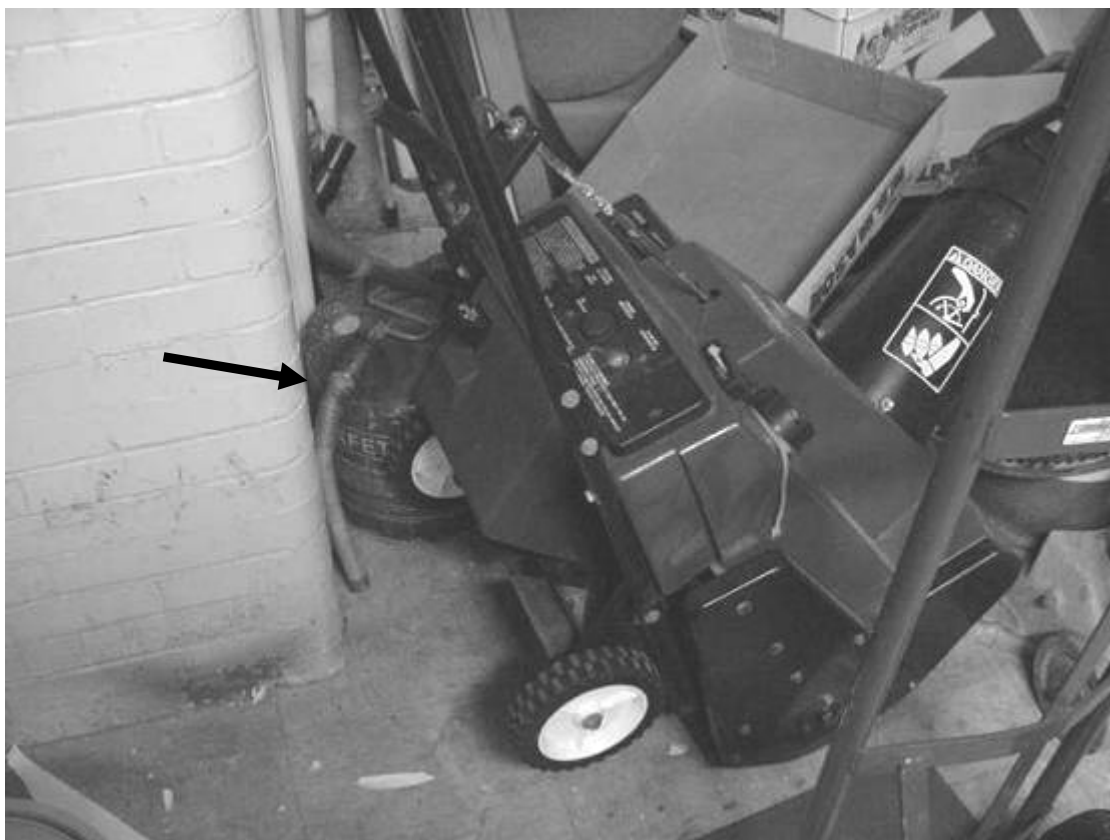
**Picture 9**

Finally, a gas-powered snow blower and gasoline container were being stored in the air-handling room (behind the mail room/Picture 9). Odors and off-gassing of volatile organic compounds (VOCs) from gasoline can be a source of respiratory irritation and have an adverse effect on indoor air quality. In addition the storage of these items indoors can pose a fire hazard.

**Snowblower and Gasoline Can Stored in Air Handling Room (Behind Mail Room)**

13. Store gas-powered equipment and related equipment outside the building.
14. Install local exhaust ventilation to handicapped restroom to remove odors and moisture. Consider branching into existing exhaust vent for adjacent woman's restroom.
